PHASE II ENVIRONMENTAL SITE ASSESSMENT:

SUPPLEMENTAL SUBSURFACE INVESTIGATION REPORT

**Skagit County Parcel #P74143
306 Center Street
La Conner, WA 98257**

March 24, 2023

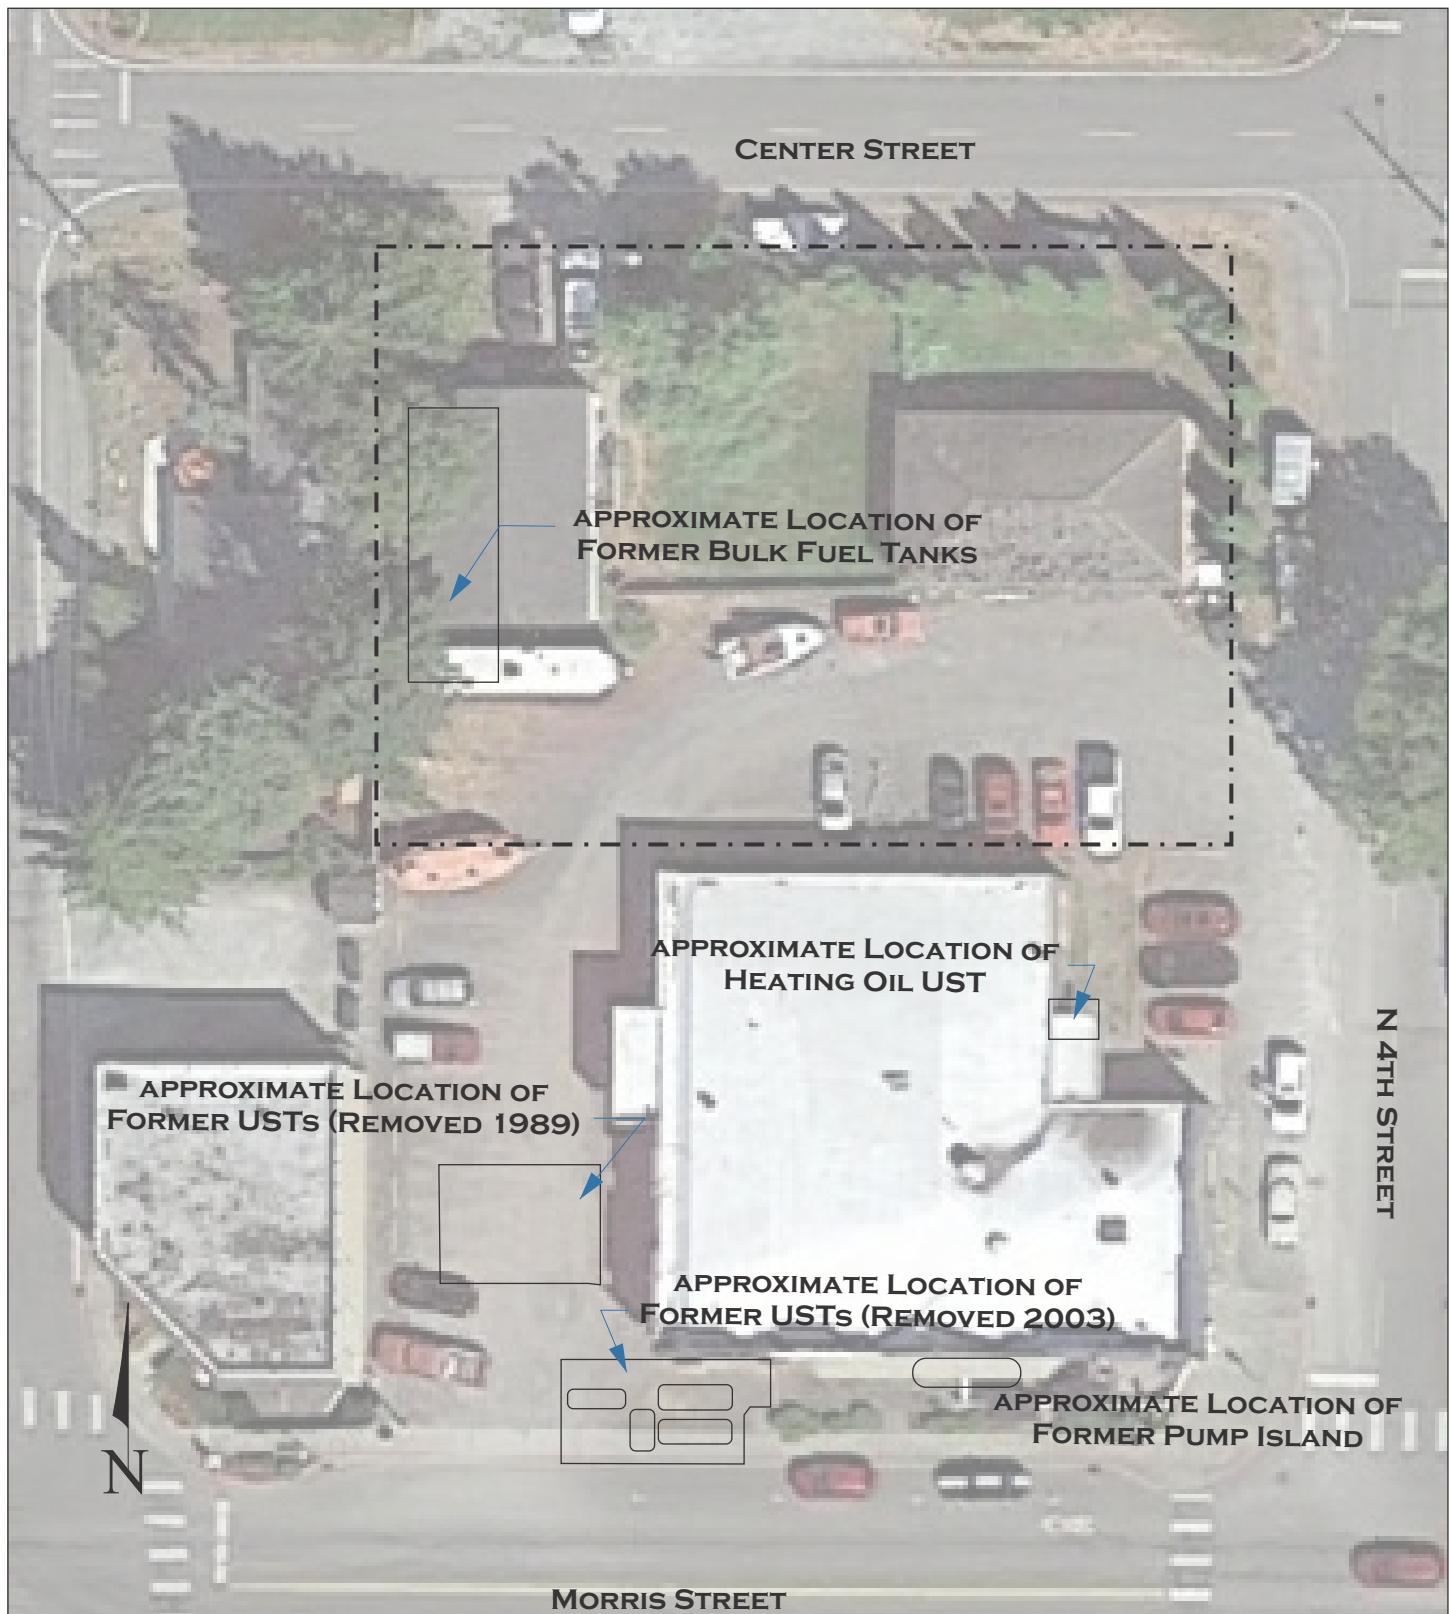
DIXON ENVIRONMENTAL SERVICES	LEGEND - - - PROPERTY BOUNDARY	SITE PLAN	
		PROJECT ADDRESS: 306 CENTER STREET LA CONNER, WA	PAGE: 2 OF 4

The Property is currently vacant, but was most recently improved with a 1,080 square foot (sf) manufactured home and detached garage. The southern portion of the Property is paved with asphalt and utilized for parking associated with a restaurant on the south adjacent parcel (Figure 2).

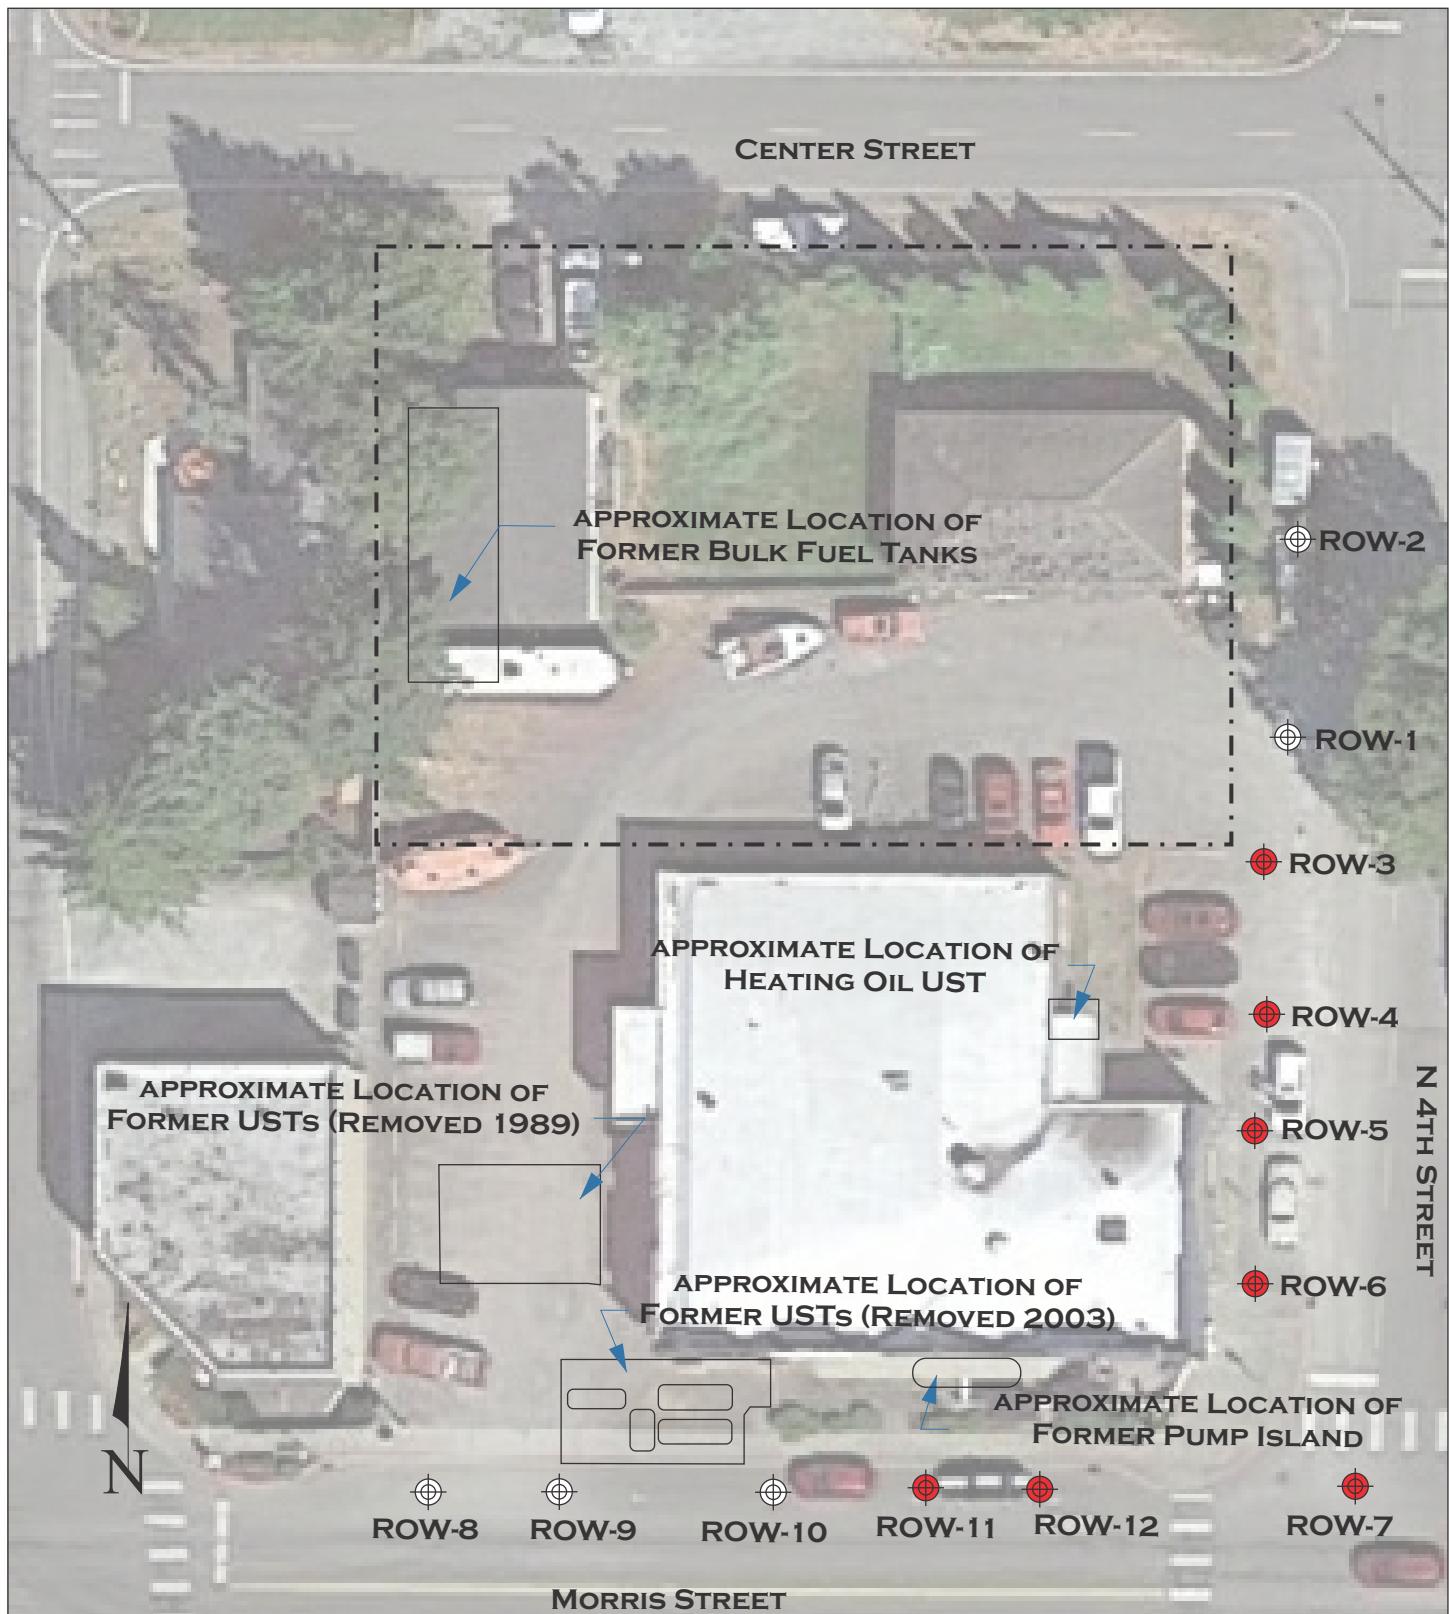
<p>DIXON ENVIRONMENTAL SERVICES</p>	LEGEND	PREVIOUS EXPLORATION LOCATIONS

BORING LOCATION (SES, 2005)

COC CONCENTRATION EXCEEDS CLEANUP LEVEL IN SOIL OR GROUNDWATER	PROJECT ADDRESS: 306 CENTER STREET LA CONNER, WA	PAGE: 3 OF 4

The subsurface investigation included the advancement of 6 borings within the Morris Street ROW and 6 borings within the 4th Street ROW (Figure 3). At least 3 soil samples were collected from each boring at depths between 2 and 12 feet bgs.

Concentrations of GRPH, DRPH, benzene, ethylbenzene, xylenes, and/or naphthalene were detected in soil at concentrations exceeding their respective MTCA Method A Cleanup Levels in borings ROW-4, ROW-5, ROW-6, ROW-7, ROW-11, and ROW-12.

Concentrations of GRPH, DRPH, benzene, and/or lead were detected in groundwater at concentrations exceeding their respective MTCA Method A Cleanup Levels in borings ROW-3, ROW-4, ROW-5, ROW-6, ROW-7, ROW-11, and ROW-12.

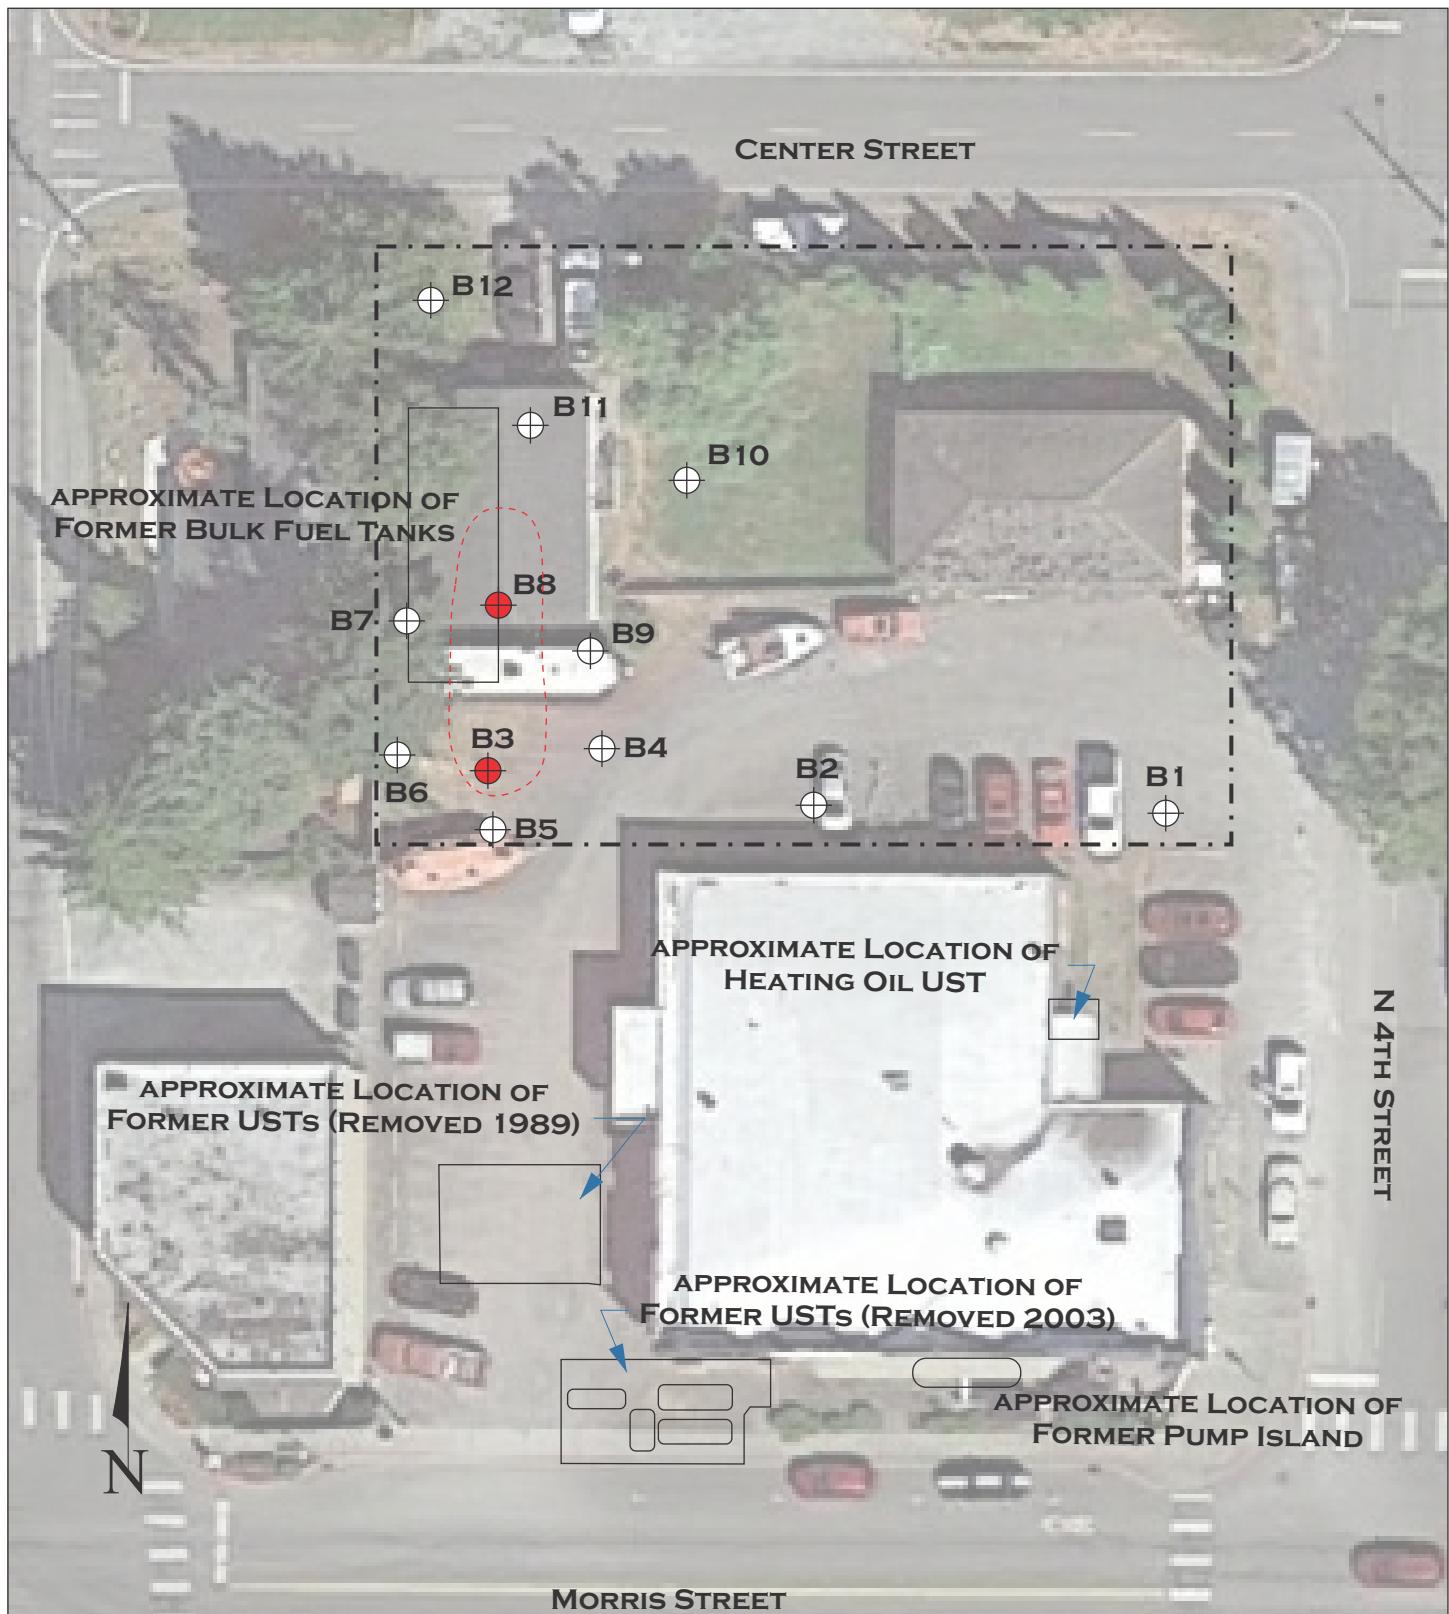
<p>DIXON ENVIRONMENTAL SERVICES</p>	<p>LEGEND</p> <ul style="list-style-type: none"> PROPERTY BOUNDARY BORING LOCATION COC CONCENTRATION EXCEEDS CLEANUP LEVEL IN SOIL 	<p>DIXON ES BORING LOCATIONS</p> <p>PROJECT ADDRESS: 306 CENTER STREET LA CONNER, WA</p> <p>PAGE: 4 OF 4</p>	
--	--	---	--

On January 28, 2022, Dixon ES oversaw the advancement of 6 borings (B1 through B6) on the Property. Borings B1 and B2 were advanced near the southern Property boundary to evaluate the potential for contaminant migration from the south adjacent parcel. B3 was also intended to evaluate potential for contaminant migration from the southern parcel, but was positioned in a location which would evaluate a potential release from the former bulk fuel tanks on the Property as well (Figure 4).

These findings suggest a lateral plume extent of approximately 500 square feet, and a vertical impact zone of between approximately 5 and 10 feet bgs. The approximate area of impacts is depicted on Figure 4.
