Soil Report 306 Center Street - Summary

306 Center Street has been the site of soil analysis in 2003, 2005, 2022 and 2023. The report by Dixon Environmental Services outlines the previous soil analysis in detail before reporting the recent results.

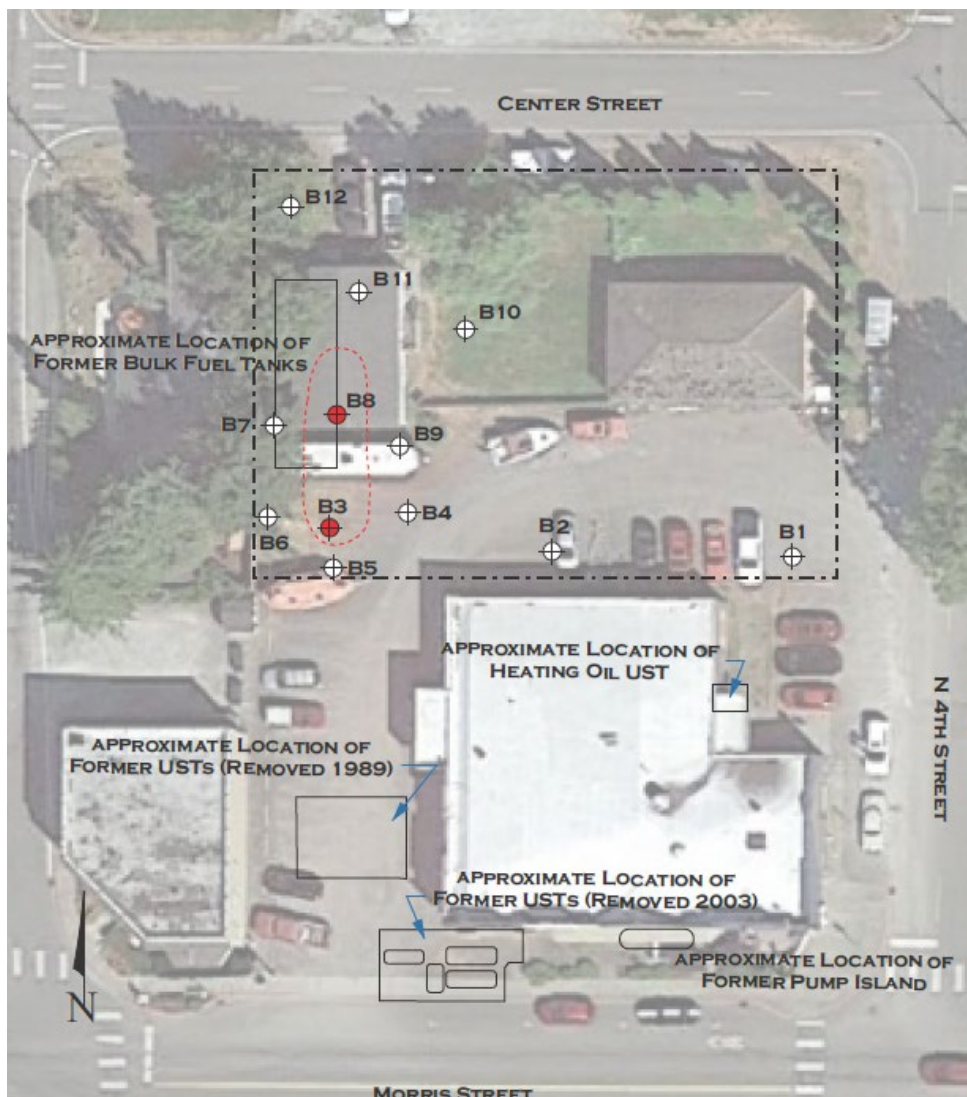
Figure 1: This photo shows the 12 boring sites where soil samples were taken in 2022 and 2023. The borings marked in red (B3 and B8) indicate contaminants detected in the soil.

In 2022, Dixon Environmental Services analyzed the findings of the past soil analysis and the historical use of the property to determine that a focused investigation of the southern property line would allow evaluation of the known releases, as well as evaluation of the potential impacts of the above ground fuel tanks previously on the property. Borings B1 – B6 were taken at this time, and tested for contaminants. Only boring B3 revealed contaminants, with unacceptable levels of both GRPH and benzene being present. These results indicated that the soil had mostly likely been impacted by the above ground fuel tanks, but not significantly impacted by the underground storage tanks. The presence of a manufactured home prevented further exploration north. *See Figure 1 for boring locations.*

October 2022, the manufactured home was removed from the property. On March 7th, 2023, Dixon completed 6 additional borings (B7 – B12) designed to test for soil contaminants spread westerly, northerly, and easterly. Only B8 revealed contaminants above acceptable levels, containing both GRPH and oil-range petroleum hydrocarbons (ORPH). B8 also had detectable levels of DRPH, ethylbenzene, and xylenes, but the levels were below the threshold for clean-up as specified in the Model Toxics Control Act. No other boring revealed detectable contaminants. *See Figure 1 for boring locations.*

The soil affected by the contaminants will be removed and properly disposed of in a suitable Subtitle D landfill as required by the Hearing Examiner.
